Section 5.0

Visual Themes and Zones

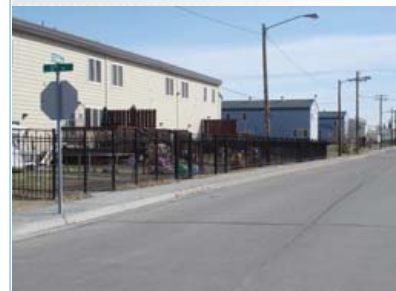
▲ **Figure 5.4d**
Typical Housing Streetscape

The housing units do not present an organized space or unifying element which can create an identity within a neighborhood group. The lack of landscape plantings adjacent to the building structure or street trees to define right of way limits creates a disorganized feeling within the neighborhoods. See Figure 5.4d. Defined social spaces are not provided within a neighborhood setting and a lack of a consistent pedestrian walkway system presents a safety concern. This visual zone will look at three neighborhood improvement projects which will address spatial organization, site amenities and landscape treatments to create identities within a neighborhood unit.

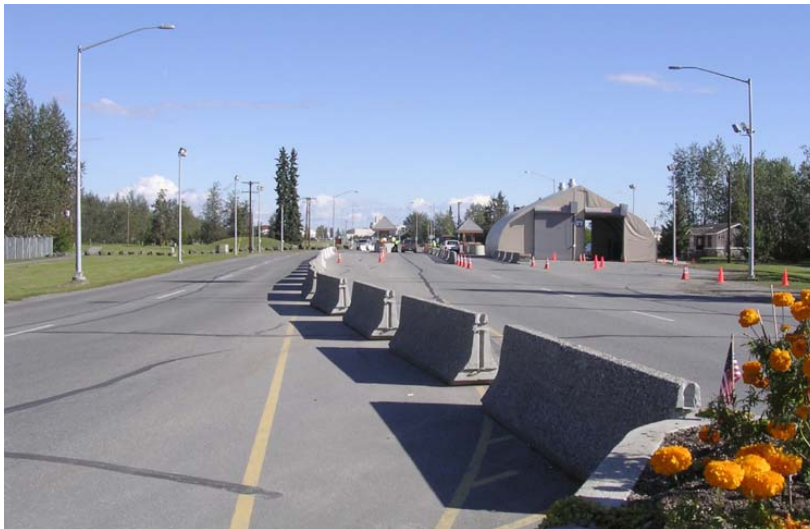
▲ **Figure 5.4e**
The Main Gate Adjoins Housing Areas

The main gate area is set back from the intersection with Richardson Highway and serves as the main entrance into the installation from the west. See Figure 5.4e. The bike path which connects to the family neighborhoods from Richardson Highway creates a security concern due to the lack of physical control on the bike path. Proposed improvements to the main gate will impact the adjoining housing area and should be considered during the design implementation process.

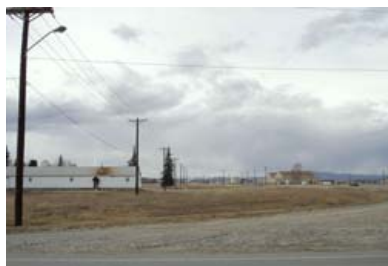
A key impact to the visual quality of the area is the starkness of the open space shown in Figures 5.5d, 5.5e, and 5.5f. Overhead utilities along Gaffney Road and Ketchum Road add to the starkness of the open space. Many of the support structures within the limits of the airfield are in disrepair and not in use which adds to the negative visual impact of the space. As a historical landmark the ability to recommend specific improvements to the airfield is not possible in this IDG. However, the visual character of the administrative quad, which is part of the historic airfield, is can be improved within the limits of a cultural resources review and the laws of National Historic Registration to enhance the quality of the area.

▲ **Figure 5.5d**
*Ladd Field View Shed Looking West
at Montgomery Road*

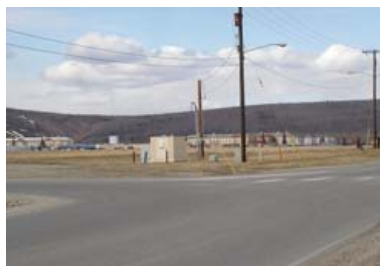
▲ **Figure 5.5e**
*Airfield Historic District Looking North
from the Intersection of Montgomery
and Ketcham Roads*

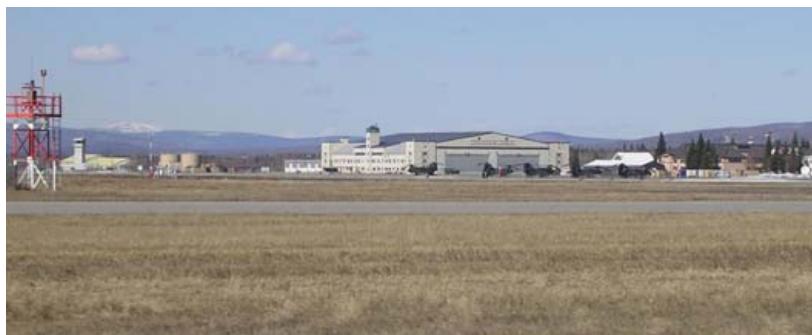
▲ **Figure 5.5f**
View of Airfield Historic District

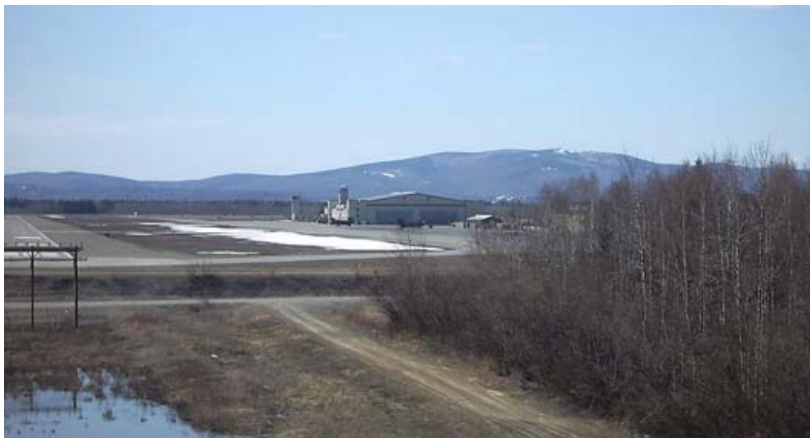
▲ Figure 5.5h

The Historic Landmark Visual Zone consists of all facilities located within the boundaries of the landmark district including view sheds from the field. The vistas from both ends of the runway are attractive and add context to the overall site. The alluvial plain on which the airfield was constructed has little to no topographic relief. The architecture of the facilities within the landmark district is utilitarian, consisting of large hangars and smaller support facilities for airfield operation. Hangars 2 and 3 are Birchwood Hangars and are two of the three remaining in the world; the third is located at Fort Greely, Alaska. Gaffney Road and Ketchum Road both cross the end of the runway within the glide path of aircraft using the field. Little security protection is present in this area with Ketchum Road in close proximity to the aircraft fueling point. Overhead utilities distract from the open space, however they do provide a definition of the perimeter of the area. See Figures 5.5g and 5.5h.

Runway Clear Zone

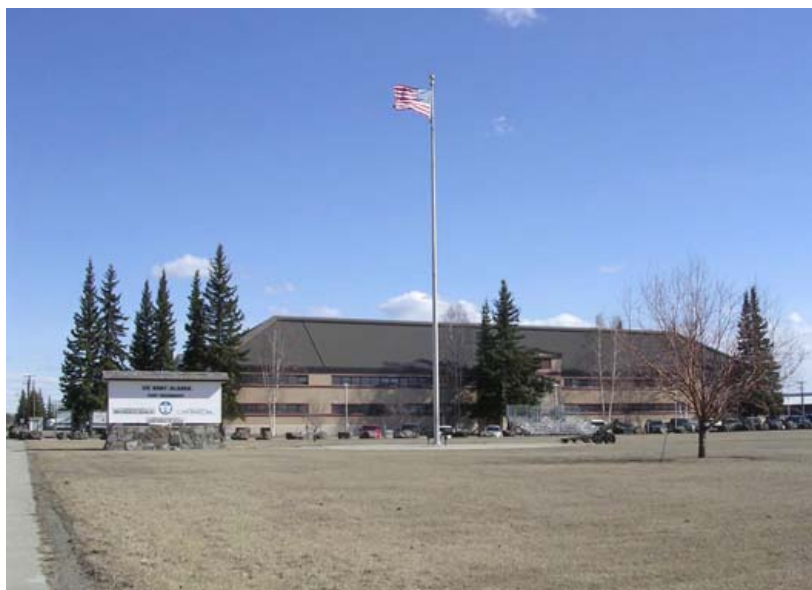
This is an intimate space within the confines of the installation and should be preserved. See Figure 5.6g. The color palette of the structures is attractive and adds interest to the area. There is a lack of trees to provide screening of the parking spaces adjacent to the buildings and some adjoining areas show a lack of maintenance.

▲ **Figure 5.6g**
Historic Administration Building

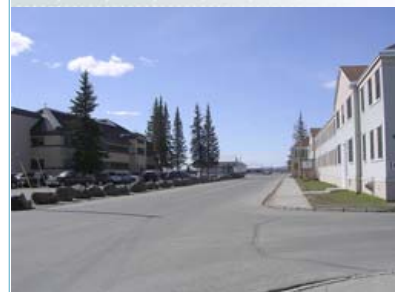
Figure 5.6h provides a typical street scene found on Gaffney Road.

▲ **Figure 5.6h**
*Gaffney Road Streetscape
Looking West*

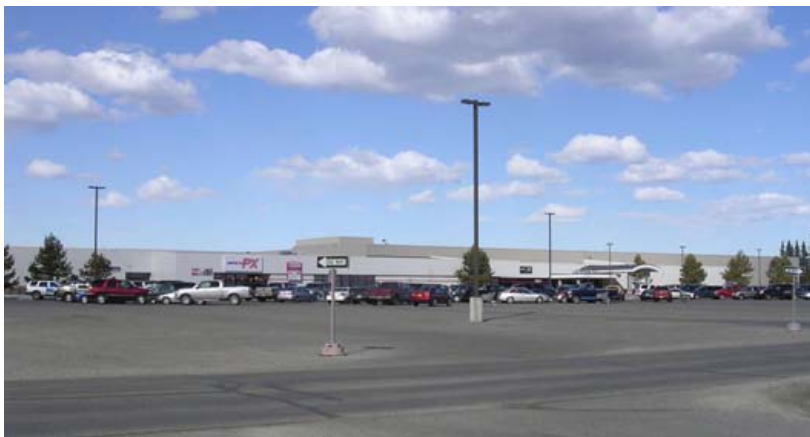
▲ Figure 5.8a

The existing exchange and commissary facility is located within the Town Center Theme area and is selected as a visual zone due to the importance of the site and the high traffic flow in the area. The exchange and commissary facility is a very large combined building with a large parking area fronting the facility as shown in Figure 5.8a. Access to the facility is from Meridian Road on the west and Santiago Avenue on the east. The parking lot is without islands or landscape screening to soften the impact of the large paved area. Large concrete bollards shown in Figure 5.8b line the front entrance walk serving as force protection barriers and parking lot light foundations. Designated pedestrian access to the facility from the parking lot or adjoining roadways does not exist. The overall appearance of the facility is uninviting and difficult to access.

Existing Exchange/Commissary Facility

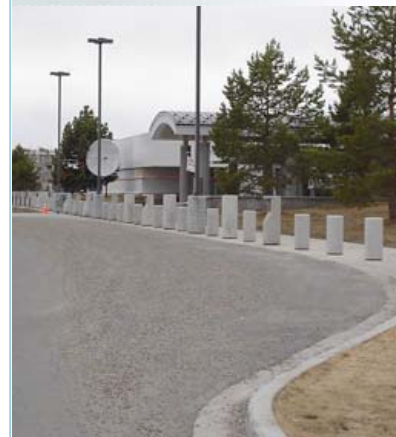
▲ Figure 5.8b

Concrete Bollards Front the Entrance

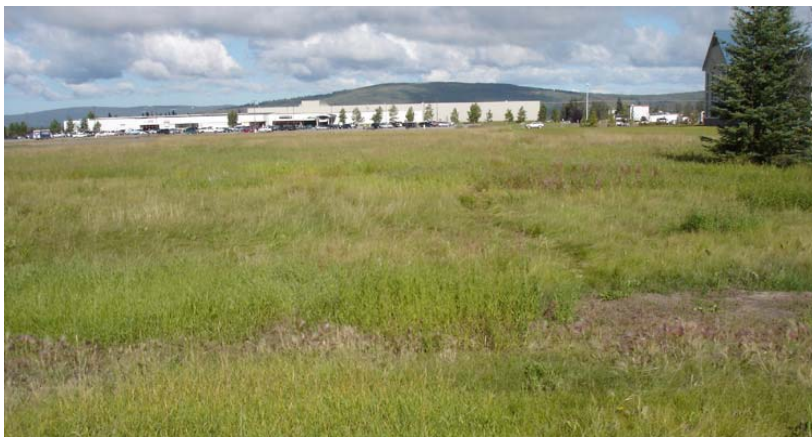
The Open Space Visual Zone is located in the Town Center Theme area and encompasses the undeveloped open space south of the Exchange/Commissary facility and east of the existing ball field complex. This area is a large open plain with grass cover. This space is seen as a key element in the creation of a central focal point for large events and passive recreational activities. There is an opportunity to create a sense of place on the installation, centrally located between family housing and enlisted barracks, and preserve the area for future creation of a memorial space for military personnel. See Figure 5.9a.

▲ Figure 5.9a
Existing Open Space
